# Asbestos Survey And Lead Paint Survey

(Revised October 15, 2014)

**Carver Elementary School  
11150 Santa Rosalia  
Stanton, CA 90680**

**Garden Grove Unified School District  
8211 Lampson Avenue  
Garden Grove, CA 92841**

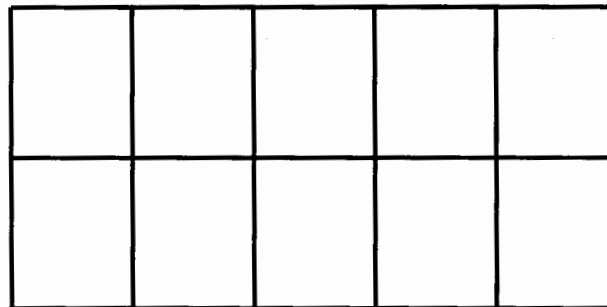
☐ 9X9 and or Mastic (asbestos)  
(some under carpet or 12X12)

Contractor to verify exact amount

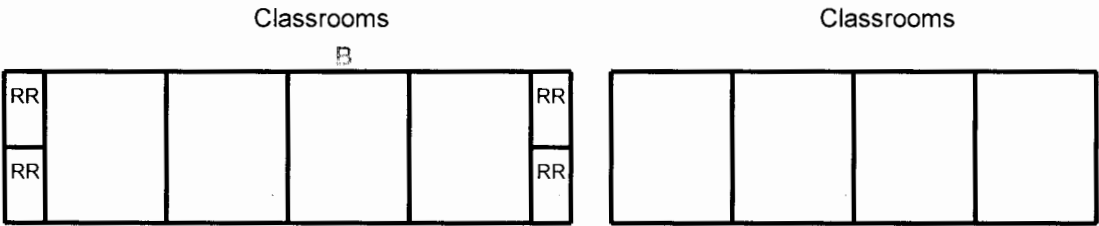
☐ 9X9 and or Mastic (asbestos)  
(some under carpet or 12X12)

Contractor to verify exact amounts
